©Kawasaki Motors Corp 1974 Printed in USA

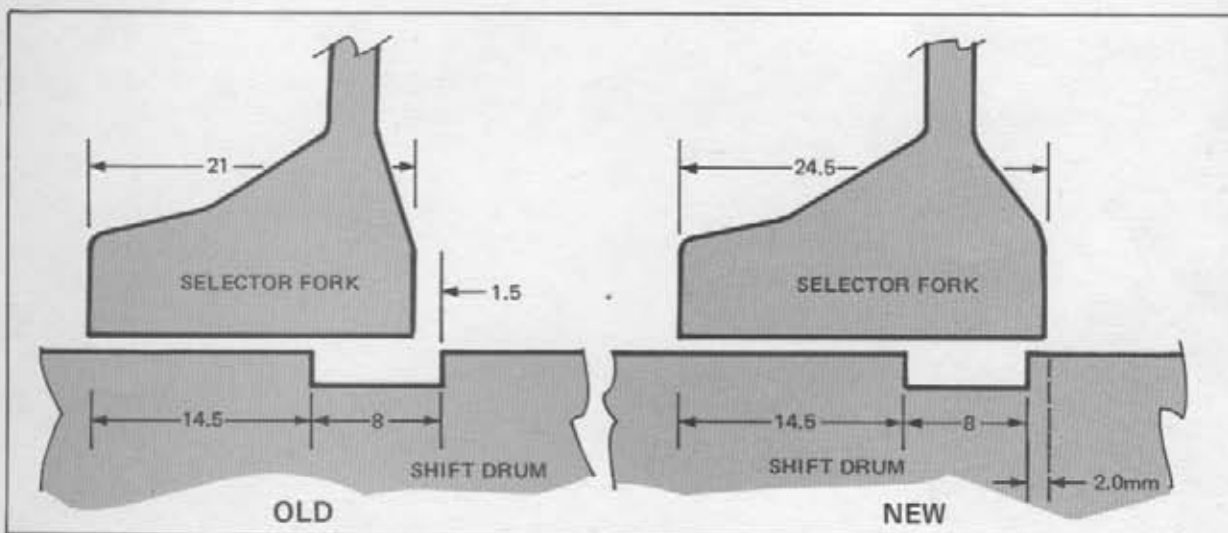
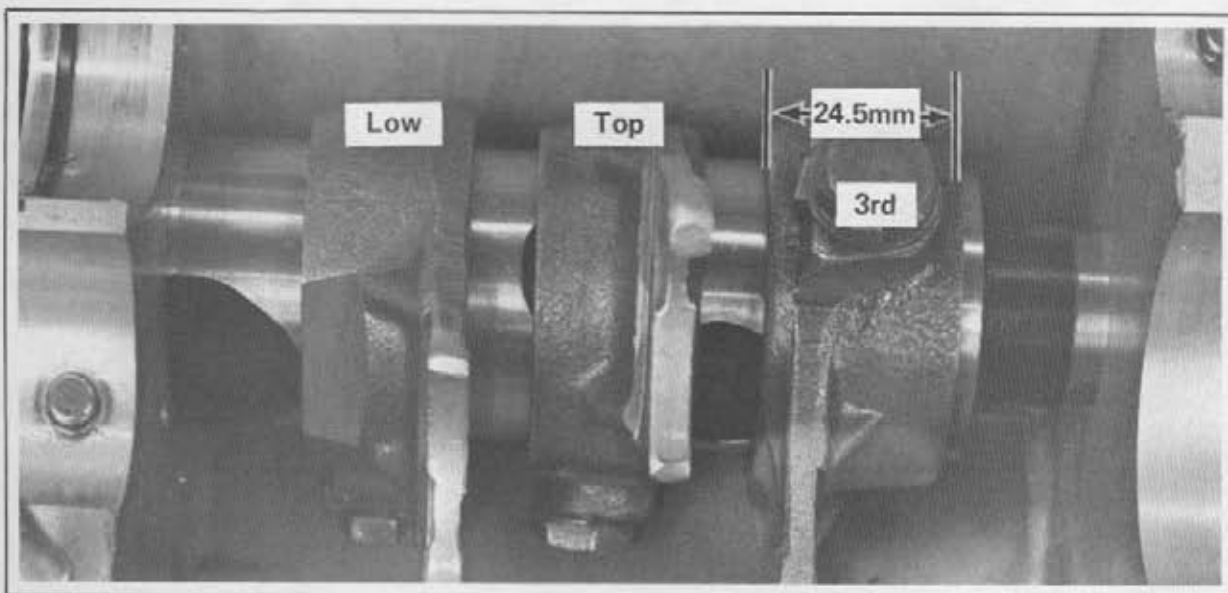
H1/H2 transmission problems have often included poor third gear engagement. This may be caused by two possible problems including the play of the fixed gears on the shafts and the lack of positive action in the third gear shift fork.

The second problem has been countermeasured by widening the base of the shift fork to keep the fork more rigid on the shift drum. This wider fork is supported on both sides of the groove on the shift drum.

The new fork is easily recognized by its wide base.

Adjustment of the play in the transmission has been improved in H1 production since engine number KAE-59017, and H2's from beginning of production. See Bulletin Ser 73 H-21 for adjustment instructions.

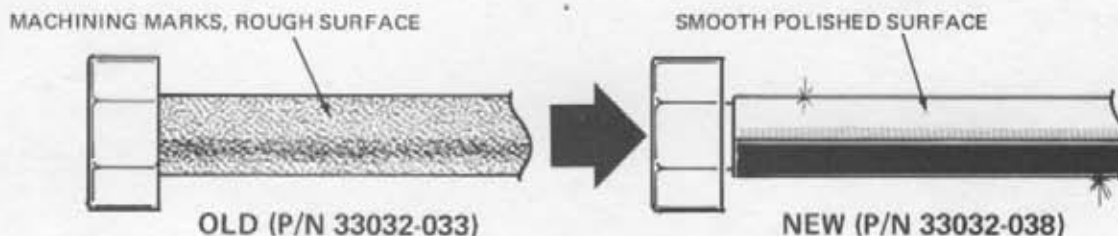
The H2A pivot shaft has a smooth polished surface as compared to the H2 pivot shaft which has a semi-rough machined surface.

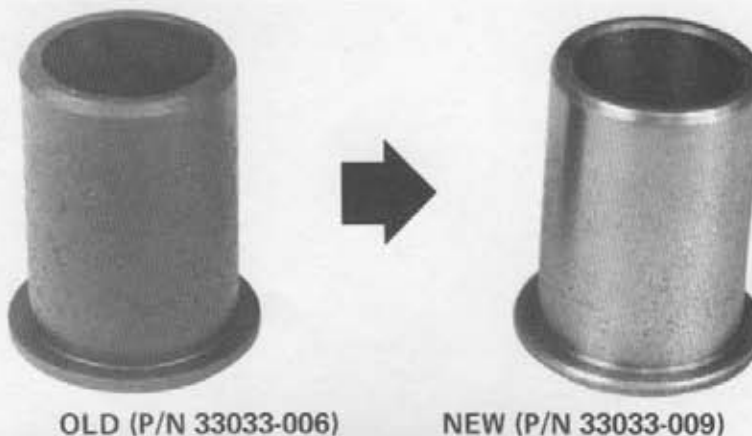
The H2 uses phenolic bushings made of a cotton or asbestos filler bonded with a phenolic resin. The H2A uses sintered iron bushings for better resistance to wear and fracture. The sintering process produces a spongelike structure in the metal making it capable of absorbing 20 percent of the total volume with lubricant. This type of bearing is ideal in areas where lubrication is infrequent.

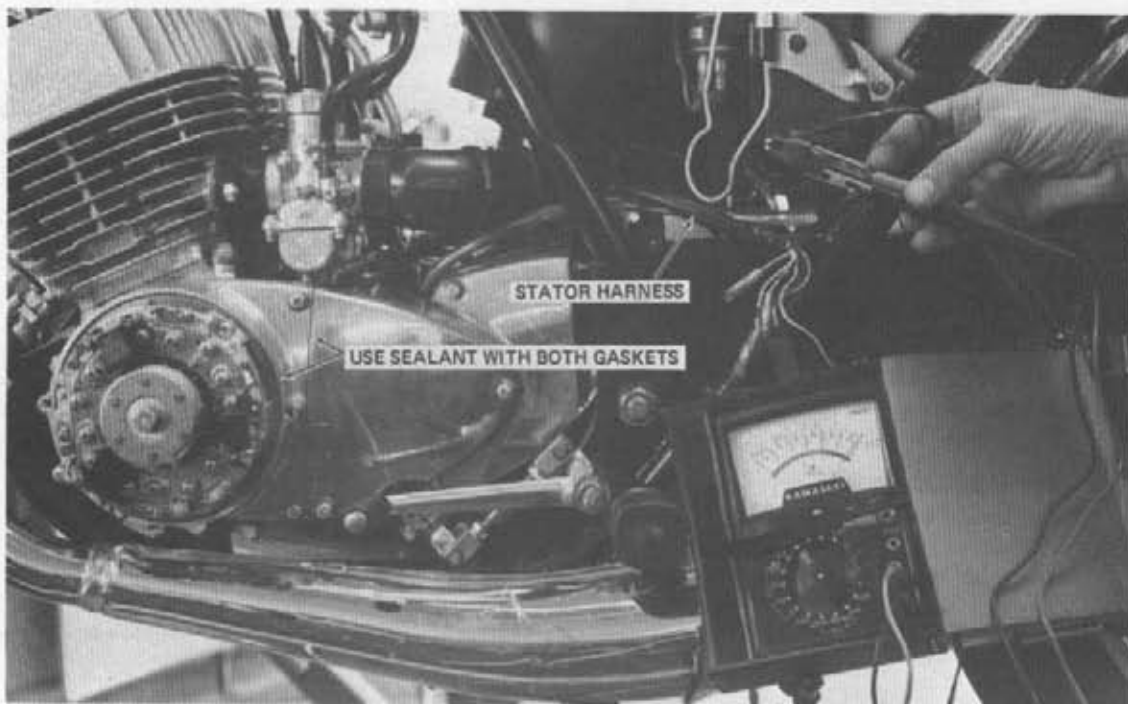
1. The insulation of the coils can be too thin in areas causing an internal short or a short to ground.
2. Engine vibration can lead to an open or short circuit.
3. Engine heat contributes to stator assembly failure.
4. Water corrosion on the AC generator due partially to condensation but primarily resulting from leakage is a large contributor to stator assembly failure.

If the stator is suspected to be defective, remove the L.H. inspection cover and visually check the stator assembly for broken wires, loose coils or other signs of damage. If nothing is found, remove the L.H. side cover and disconnect the stator wires.

The most important measures that a technician can take to prevent stator assembly failures are in preventing water from entering the L.H. engine cover. Because the inspection cover gasket (P/N 14050-005 for H1D and H2) is stiff and quite narrow, it occasionally does not conform well to the sealing surfaces of the LH engine cover and the inspection cover. G.E. Silicone Seal or any similar sealant should be used with this gasket and with the LH engine cover gasket (P/N 14045-012 for H1D and H2).

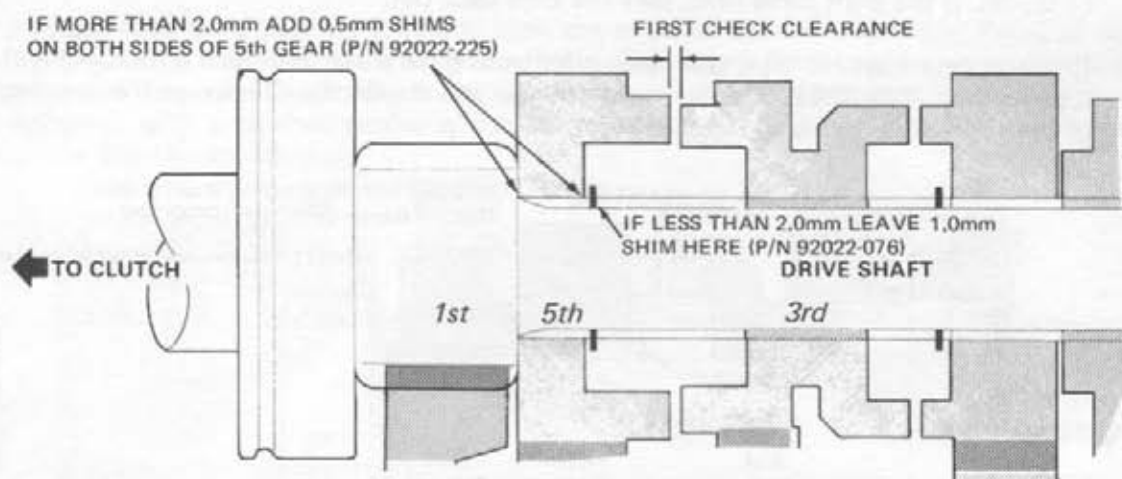
Problem	Check Clearance	Take Out	Insert
Jumping out of 5th gear.	Ck clearance between 5th and 3rd gear dogs on drive shaft.	If clearance is greater than 2.0mm take out 1.0mm shim between 5th and circlip.	Insert 0.5mm shim (P/N 92022-225) on either side of 5th gear on the drive shaft.
		If less than 2.0mm leave shim where it is.

- To eliminate jumping out of fifth gear, measure the clearance between fifth and third gear dogs on the drive shaft. If the clearance is over 2.0mm, remove the factory installed 1.0mm shim (P/N 92022-076) between fifth gear and the circlip, and add a 0.5mm (92022-225) shim on either side of fifth gear. This moves fifth gear 0.5mm closer to the slider gear, assuring a more positive engagement. If the clearance is less than 2.0mm between dogs on the two gears, then leave the 1.0mm shim where it is.

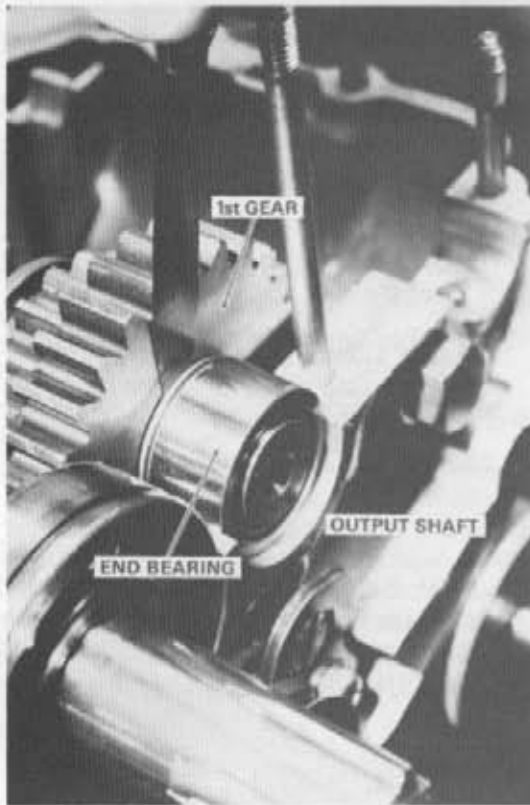
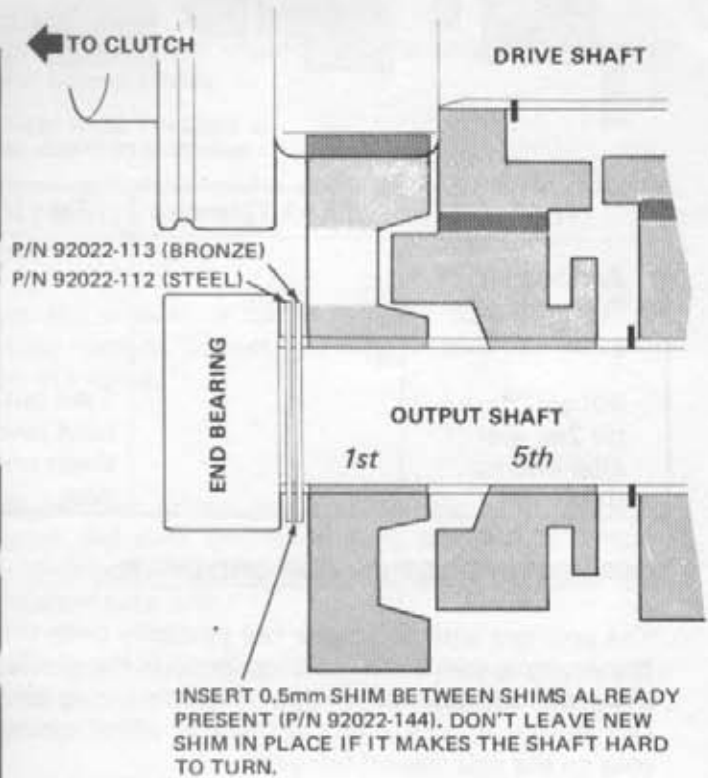
Problem	Check Clearance	Take Out	Insert
Poor 1st gear engagement.			Add 0.5mm shim (P/N 92022-144) between first gear and end bearing on the output shaft.
Transmission binds after adding shim.		Take out new shims.

To correct poor engagement of 1st gear, insert an 0.5mm shim (P/N 92022-144) between first gear and the end bearing on the output shaft. This is in addition to the shims already present (P/N 92022-112, -113). This moves 1st gear slightly closer to the slider gear and eliminates play which may have contributed to jumping out of gear. If adding this shim makes the output shaft hard to turn, then take it back out.

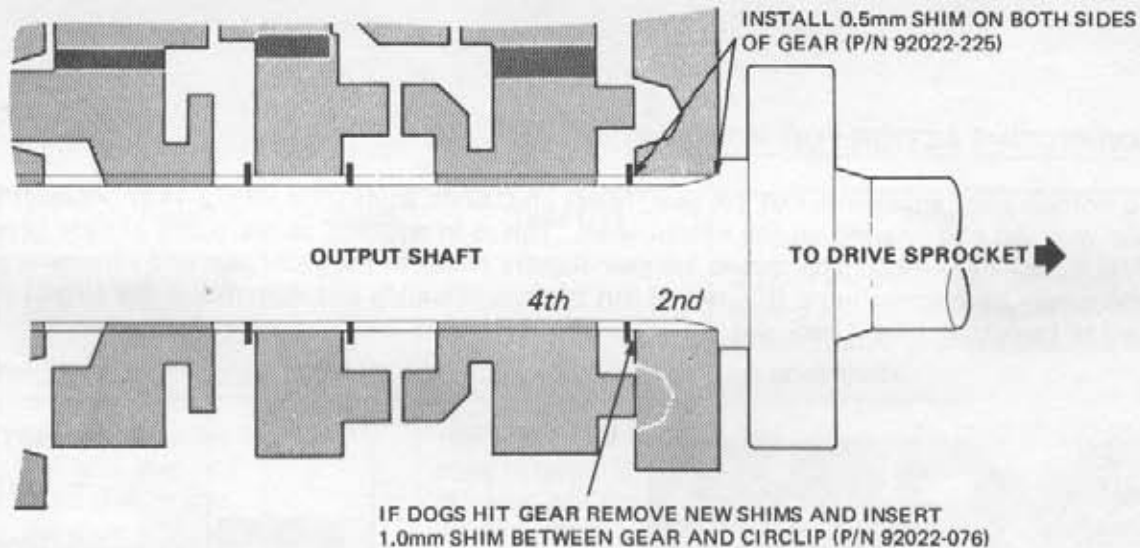
Problem	Check Clearance	Take Out	Insert
Jumping out of 2nd gear.			Add 0.5mm shim (92022-225) on both sides of 2nd gear on the output shaft.
4th gear dogs hit 2nd gear after adding shims.		Take out both new shims on 2nd gear.	Add 1.0mm shim (92022-076) between 2nd gear and circlip on output shaft.

To eliminate play at second gear on the output shaft, install a 0.5mm washer (P/N 92022-225) on both sides of the gear. This moves the gear slightly closer to the fourth gear slider as well as reducing play. If the dogs on fourth gear hit second gear after the shims are added, remove both new shims and add a 1.0mm shim (92022-076) between second gear and the circlip. This will keep the dogs from hitting, while eliminating play at second gear.

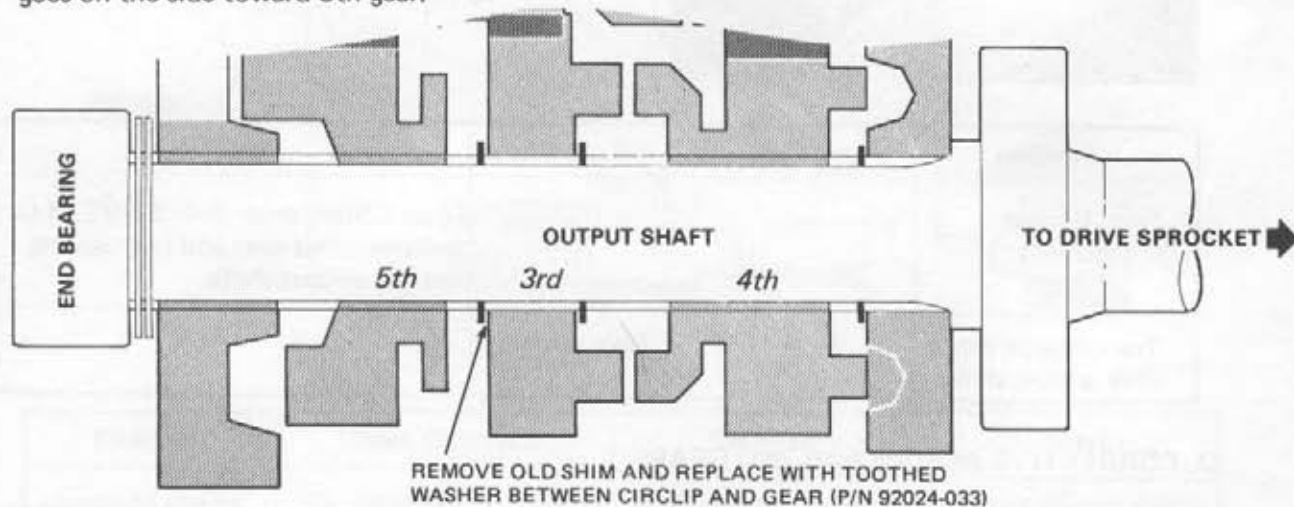
The problem with third gear has primarily been the result of the shim between 3rd gear and the circlip spinning and wearing through the circlip. This causes third gear to move away from the slider and hop out of gear. The solution is to remove the standard shim (P/N 92022-076) and replace it with a toothed washer which cannot rotate (P/N 92024-033). The new washer goes on the side toward 5th gear.

Problem	Check Clearance	Take Out	Insert
Jumps out of 3rd gear.		Remove 1.0mm shim between 3rd gear and circlip on output shaft.	Insert 1.0mm toothed thrust washer (P/N 92024-033) between 3rd gear and circlip (5th gear side).

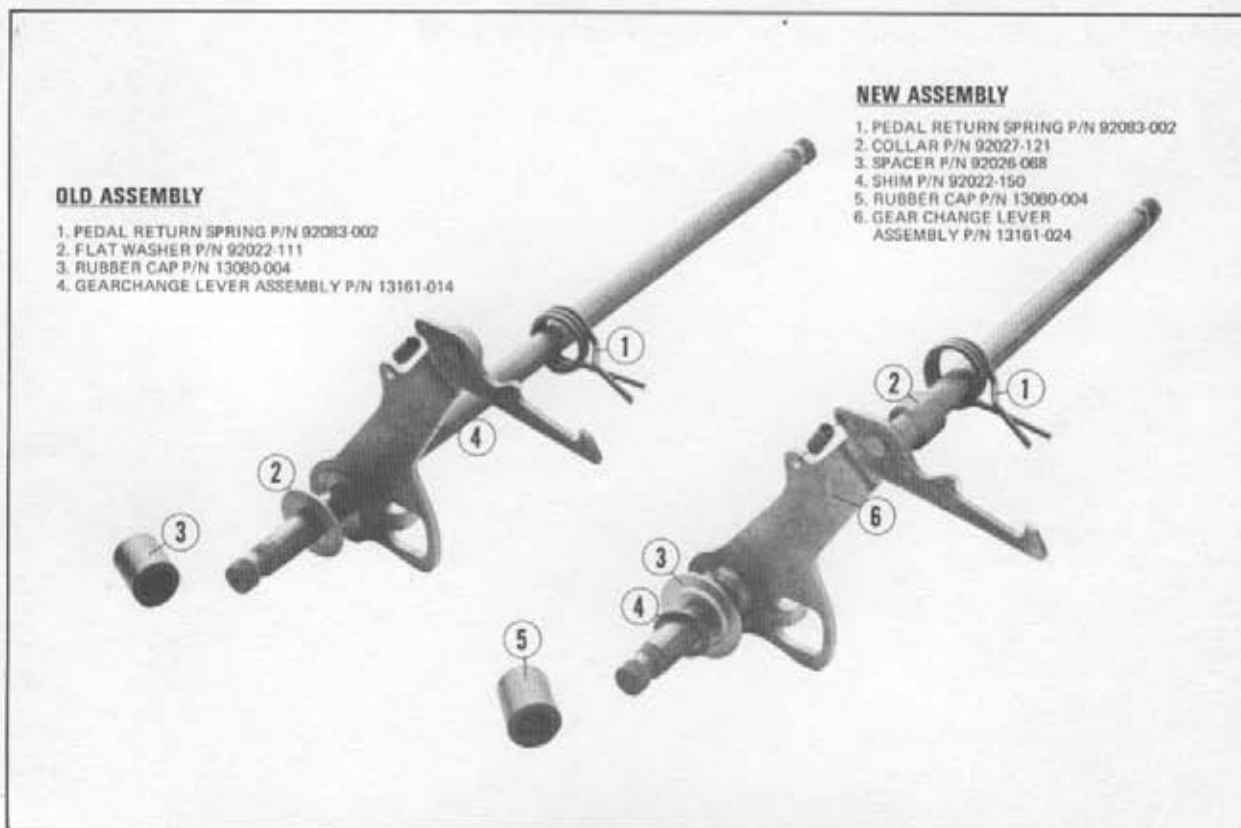
On the early H1 models, the gear change lever assembly consisted of a toothed lever staked to a rod. This construction sometimes loosened up, causing sloppiness in shift lever movement. This contributed to missed shifts, and sometimes led to transmission damage.

The correct assembly of the new gear change lever assembly is pictured on the right below. The outside shim (P/N 92022-150) does not yet appear in any parts books but it is included in the position shown on current production machines of both H1 and H2. The new assembly is used on all H1's after Engine No. KAE 43902 and on all H2's, and is interchangeable with older parts.

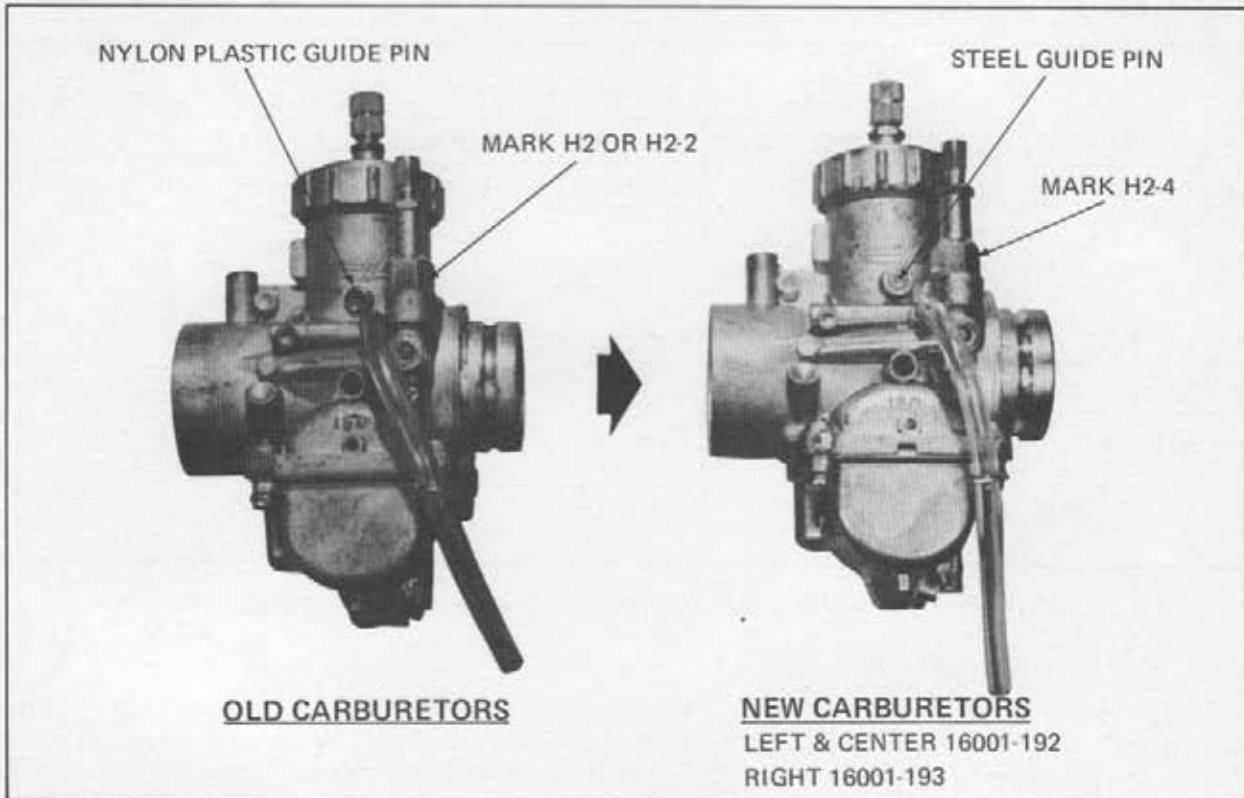
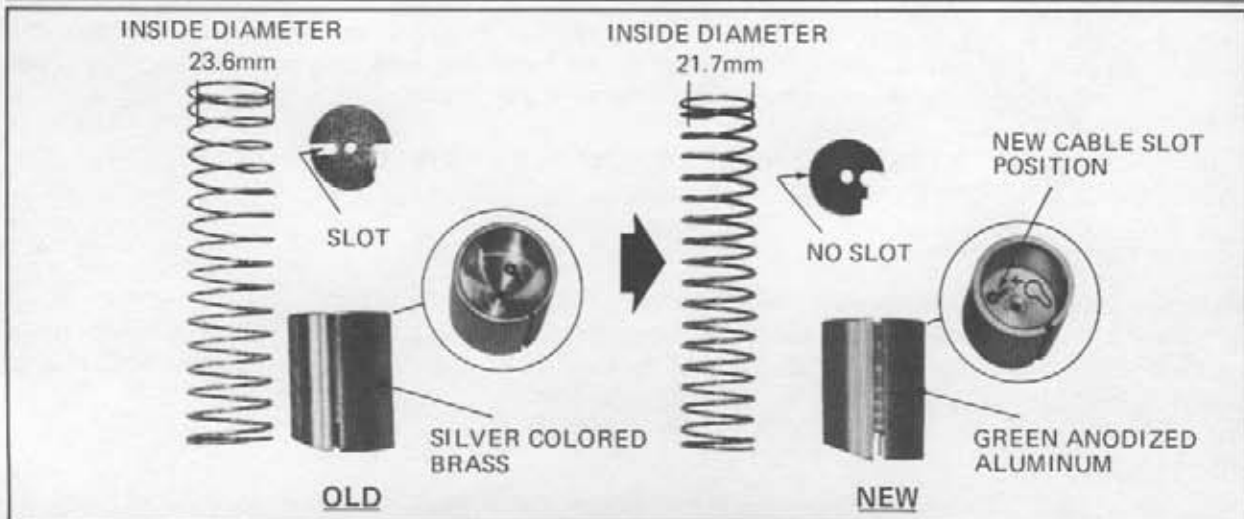
By monitoring warranty records, it has been determined that carburetor jet needle breakage is a recurring problem on many H2's. This failure results from the combination of throttle valve bore wear and engine vibration. In some cases, the broken jet needle has become lodged in the engine, causing severe damage.

To remedy the problem of jet needle breakage and reduce the possibility of engine damage, the three original carburetors must be replaced with new-type carburetors designed specifically to eliminate this problem. The new carburetors incorporate a redesigned light weight throttle valve slide, a heavier return spring, a modified spring seat, and a steel throttle valve guide pin. All other component parts remained unchanged from the "H2-2" type carburetor.

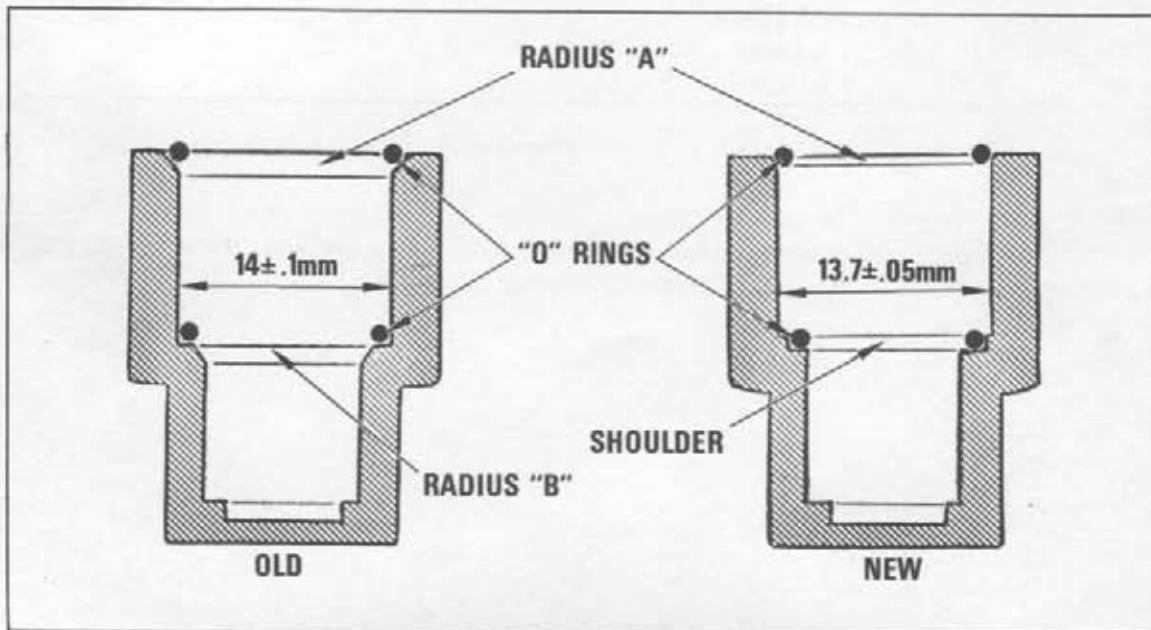
This problem has been traced to faulty O-ring seating in the oil pump end cover. After installation, the two O-rings inside the cover shrink approximately .1 to .2mm in diameter. This shrinkage allows oil to seep around the seals and into the end cover chamber. From this point, the excess oil is pumped to the right cylinder which is serviced by the end cover orifice, resulting in smoking and premature sparkplug failure.

It should be noted that other symptoms may indicate oil pump malfunction, such as right hand piston seizure. This may be caused by oil being forced back into the main pump body through defective O-rings. As a result, the right cylinder is starved for oil, and this situation will eventually lead to seizing.

- Radius "A" has been decreased in depth to give the O-rings less "squish" space, making a tighter seal.
- Radius "B" has been eliminated altogether, improving the seal at this point.
- The internal diameter of the chamber has been decreased from  $14 \pm .1\text{mm}$  to  $13.7 \pm .05\text{mm}$  to compensate for O-ring shrinkage.
- A slight shoulder has been added to the base of the new chamber to further compress the O-ring.

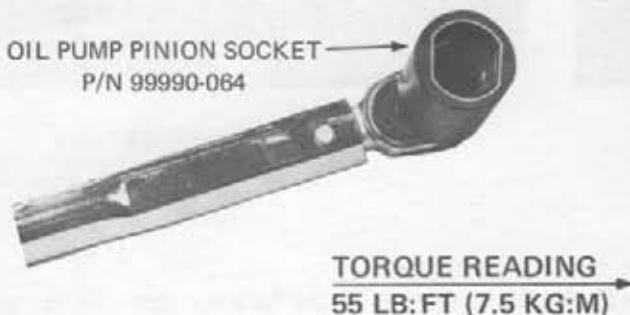
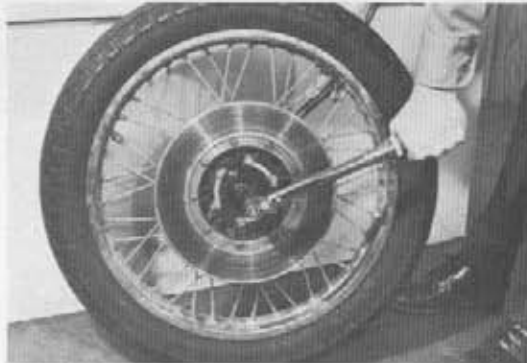
- C. **AXLE TORQUE:** Make sure that the front axle is tightened to 55 lb.-ft. (7.5 kg-m). Several cases of speed wobble have been traced to loose axles. **NOTE:** To ensure an accurate torque measurement, use a torque wrench and an Oil Pump Pinion Socket, P/N 99990-064 (refer to National Parts Bulletin #72-9, June 26, 1972). These sockets fit the flattened ends of the H2 axle perfectly, and adapt to any 3/8" square drive.

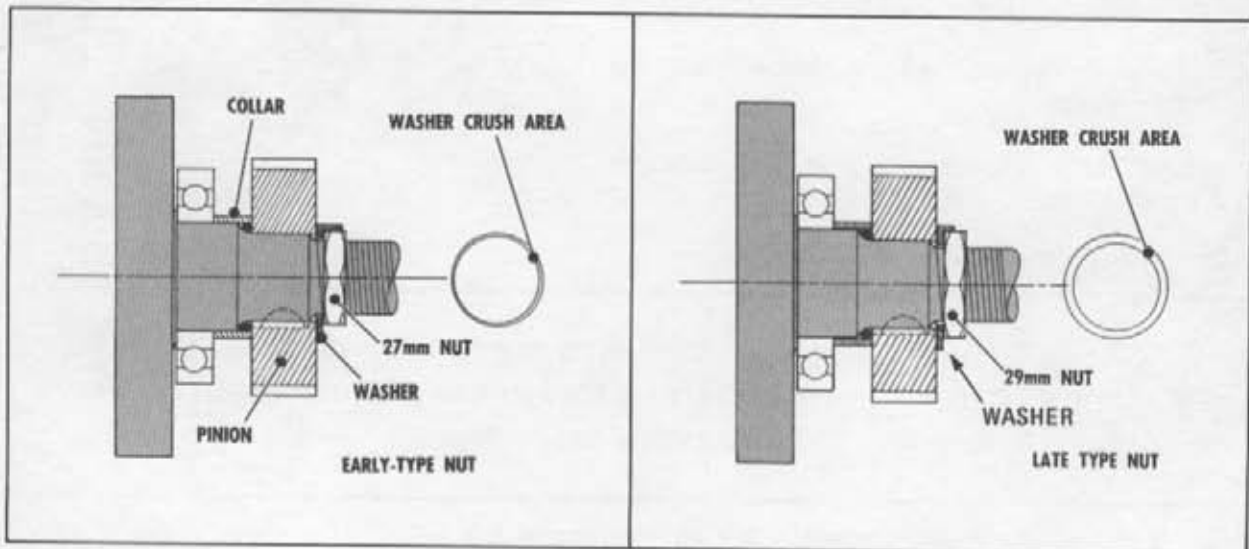
Surprisingly, the primary pinion nut does not loosen (turn) on the crankshaft. Instead, the lockwasher is crushed, relieving the pinion of nut tension. Then the gear is held from twisting only by the woodruff key. As the drawing below shows, the "crush" area on the lockwasher, which is determined by the I.D. of the pinion gear and the O.D. of the pinion nut, is very small.

The knocking results from the pinion keyway hitting the woodruff key as the pinion twists on the crankshaft.

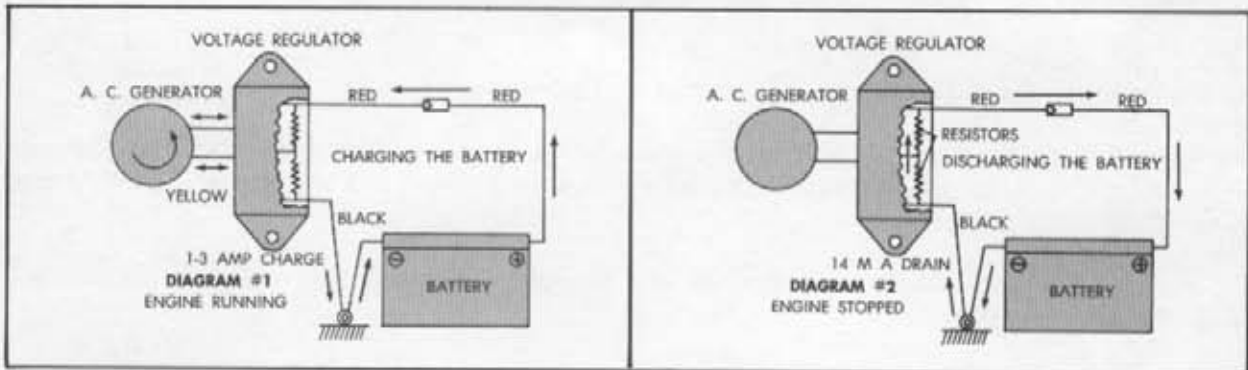
The H2 voltage regulator is connected to the battery by a red wire. This red wire carries the battery charging current when the engine is running. Because of two small resistors in the regulator circuitry, there is a slight current drain on the battery when the engine stops. In a fully charged state, it would take 2-3 weeks of inactivity for the battery to reach a serious discharge condition, because the current draw is so small (12-16 MA).

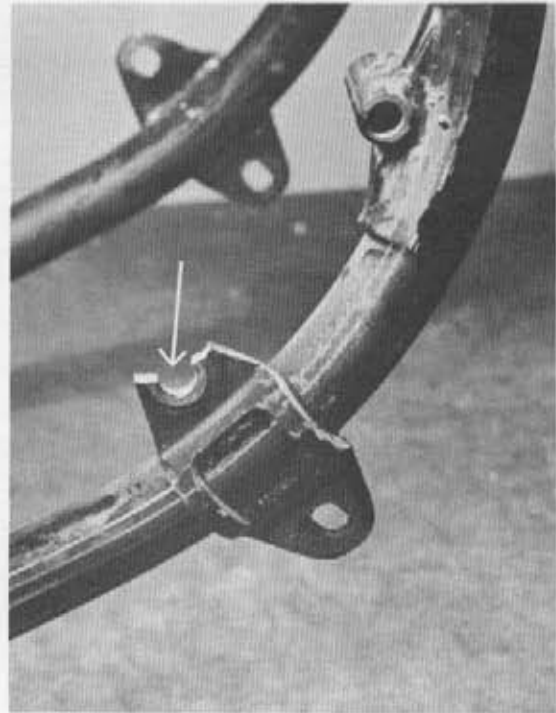
The frame lugs have 1.0-1.5mm clearance with the engine mounting bosses to allow easy removal/installation. These lugs are meant to be pulled in as the bolts are tightened. It has been found that the lugs take a "set", relieving tension on the mounting bolts.

Engine mount shims must be used to take up the clearance between the frame lugs and engine bosses at the two bottom mounts. The factory has installed these shims on all H2's after Frame No. H2F-09082.

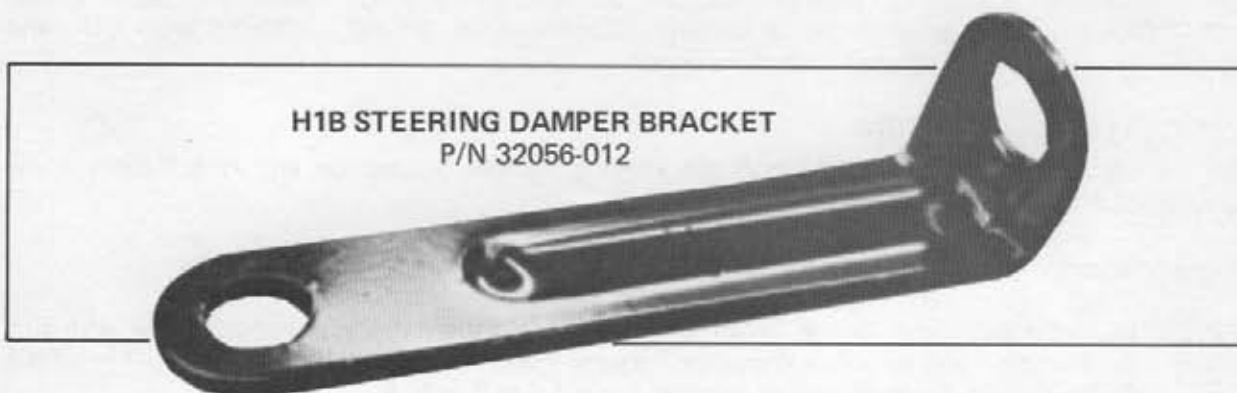
With the damper in the #5 (hardest) position, the push-pull force can cause the damper rear frame stanchion to flex and bend.

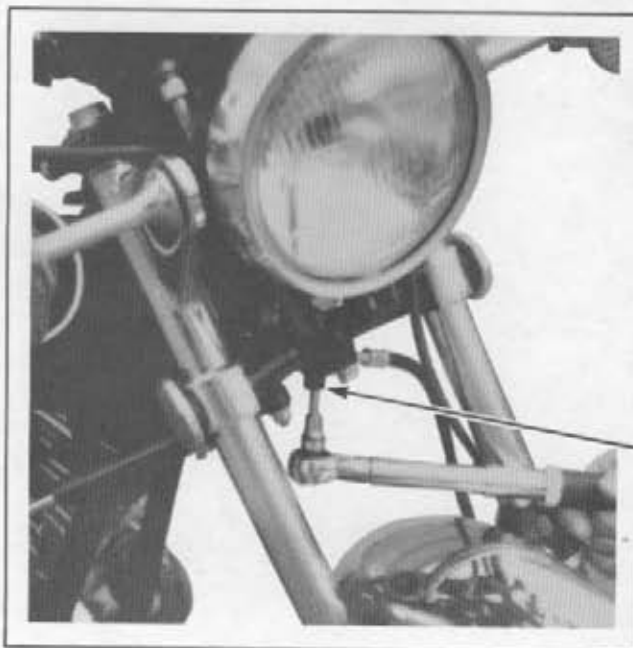
TIGHTEN TO  
3.0 kg-m  
(22 ft-lb)

On some H1E's between Frame Numbers H1F-025000 and H1F-030300 there may be a brake fluid leak around the allen bolt on the bottom of the steering stem.

- 1) Tighten this allen bolt on all affected H1E's to 3.0 kg-m (22 ft-lb).
- 2) If the bolt was loose, or if there are signs of brake fluid leakage, check brake lever operation and master cylinder brake fluid level.
- 3) If the brake lever is soft or if fluid level is low, bleed the brake system. Refer to H Series Shop Manual, Page 78.

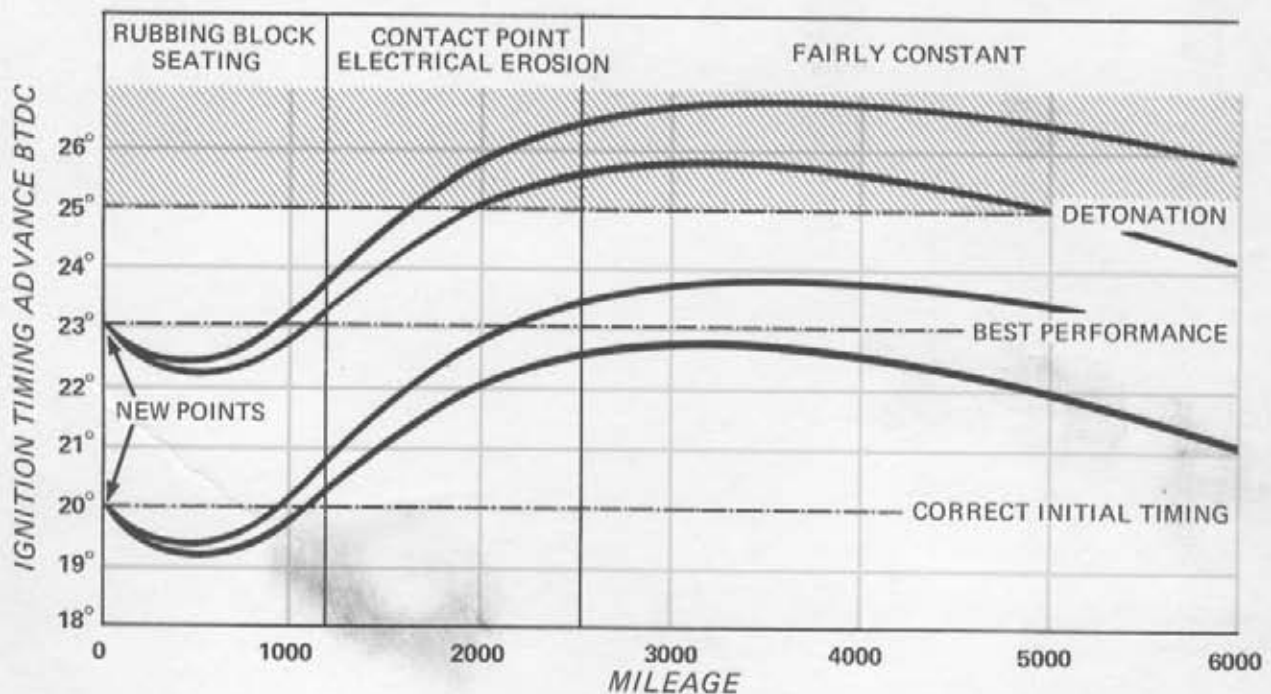
H1-B IGNITION TIMING CHANGE OVER FIRST 6000 MILES

Optimum ignition timing for the H1B is 23° (2.94mm) BTDC. The H1B has no ignition timing advance. The timing remains at a fixed point throughout the RPM range. However, as the graph below shows, if new points are initially set at 23° they will soon retard 1° because of rubbing block wearing-in, and then advance to more than 25° (from contact erosion) where detonation causes piston holing and severe engine damage. Since engine performance varies little from 19° to 25°, the factory recommends that new points be set at 20° BTDC (2.23mm). From this setting the timing will advance to 23° by itself in a matter of a few thousand miles. After 3000 miles, point wear levels off, so that when the points are adjusted after that time, they should be set at 23° until they are replaced.

**NOTE:** If plug fouling or sluggish performance is a serious problem on a new H1B, advancing the timing to 23° right away may solve the problem, but it will be necessary to check and adjust the timing frequently during the first few thousand miles to prevent engine damage due to overadvanced timing.

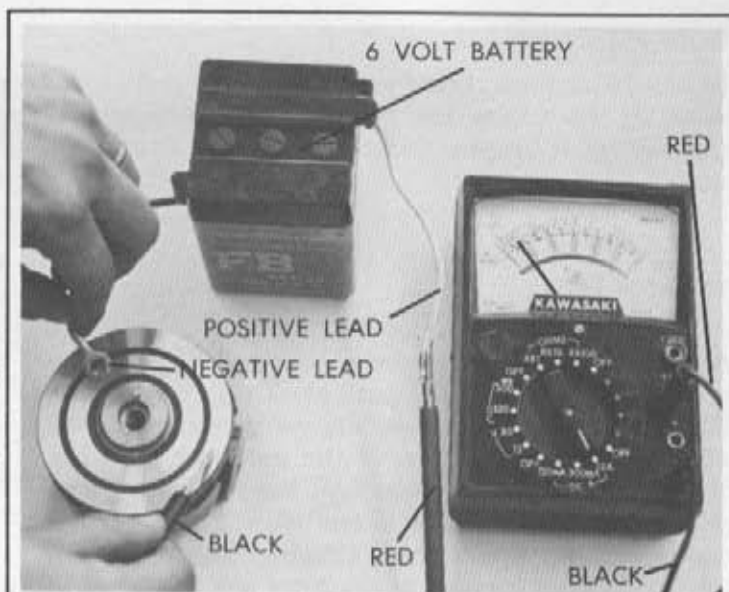
A defect which shows up only under load may be detected as follows. Set the selector switch to the "12 A" position and plug the red lead into the "+12 A" hole. Connect the red lead to the positive lead from a six volt test battery. **CAUTION:** Don't use a 12V battery or you could ruin the rotor windings. Touch the negative lead from the battery to one of the rotor slip rings. Momentarily, tap the black lead from the multimeter on the other slip ring. If the needle swings wildly across the face of the meter the rotor is shorted.

Do not hold the black lead to the slip ring under these conditions or the multimeter will be damaged. If the needle rises to 1.1 to 1.7 amps (read the 0 to 120 scale as 0 to 12.0 amps) the rotor is good. A lower reading indicates an open circuit.

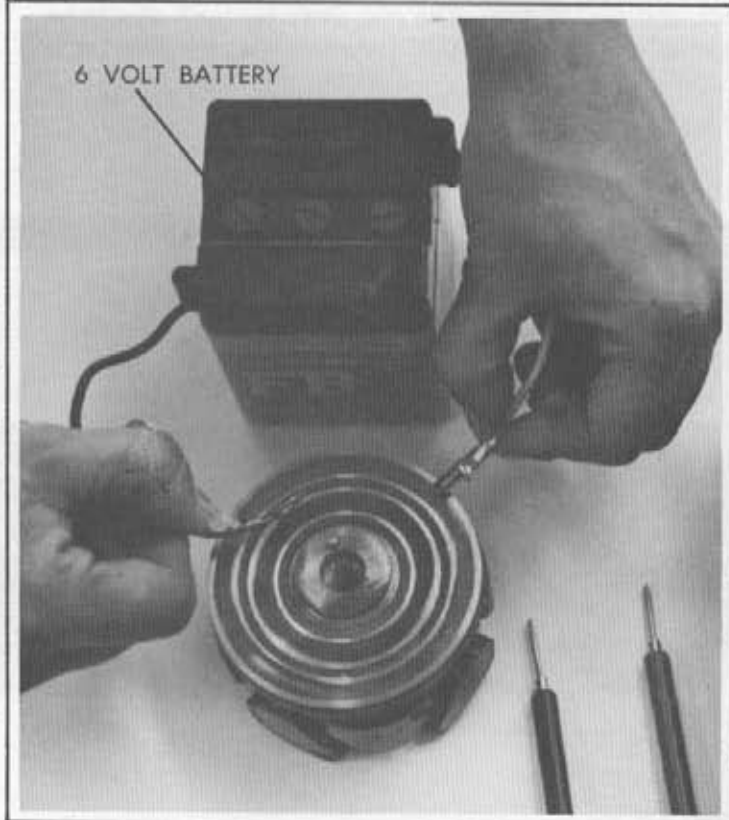
SQUARE HOLE IN CLOTH

The alternator rotor, being mounted on the end of the crankshaft, turns at the same speed as the engine. At high engine rpm, the centrifugal force on the rotor winding is considerable. Failure of the rotor can result because the winding is stretched and either shorted or snapped by the tremendous force.

With any of these types of failure, the rotor must be replaced.
