©Kawasaki Motors Corp 1974 Printed in USA

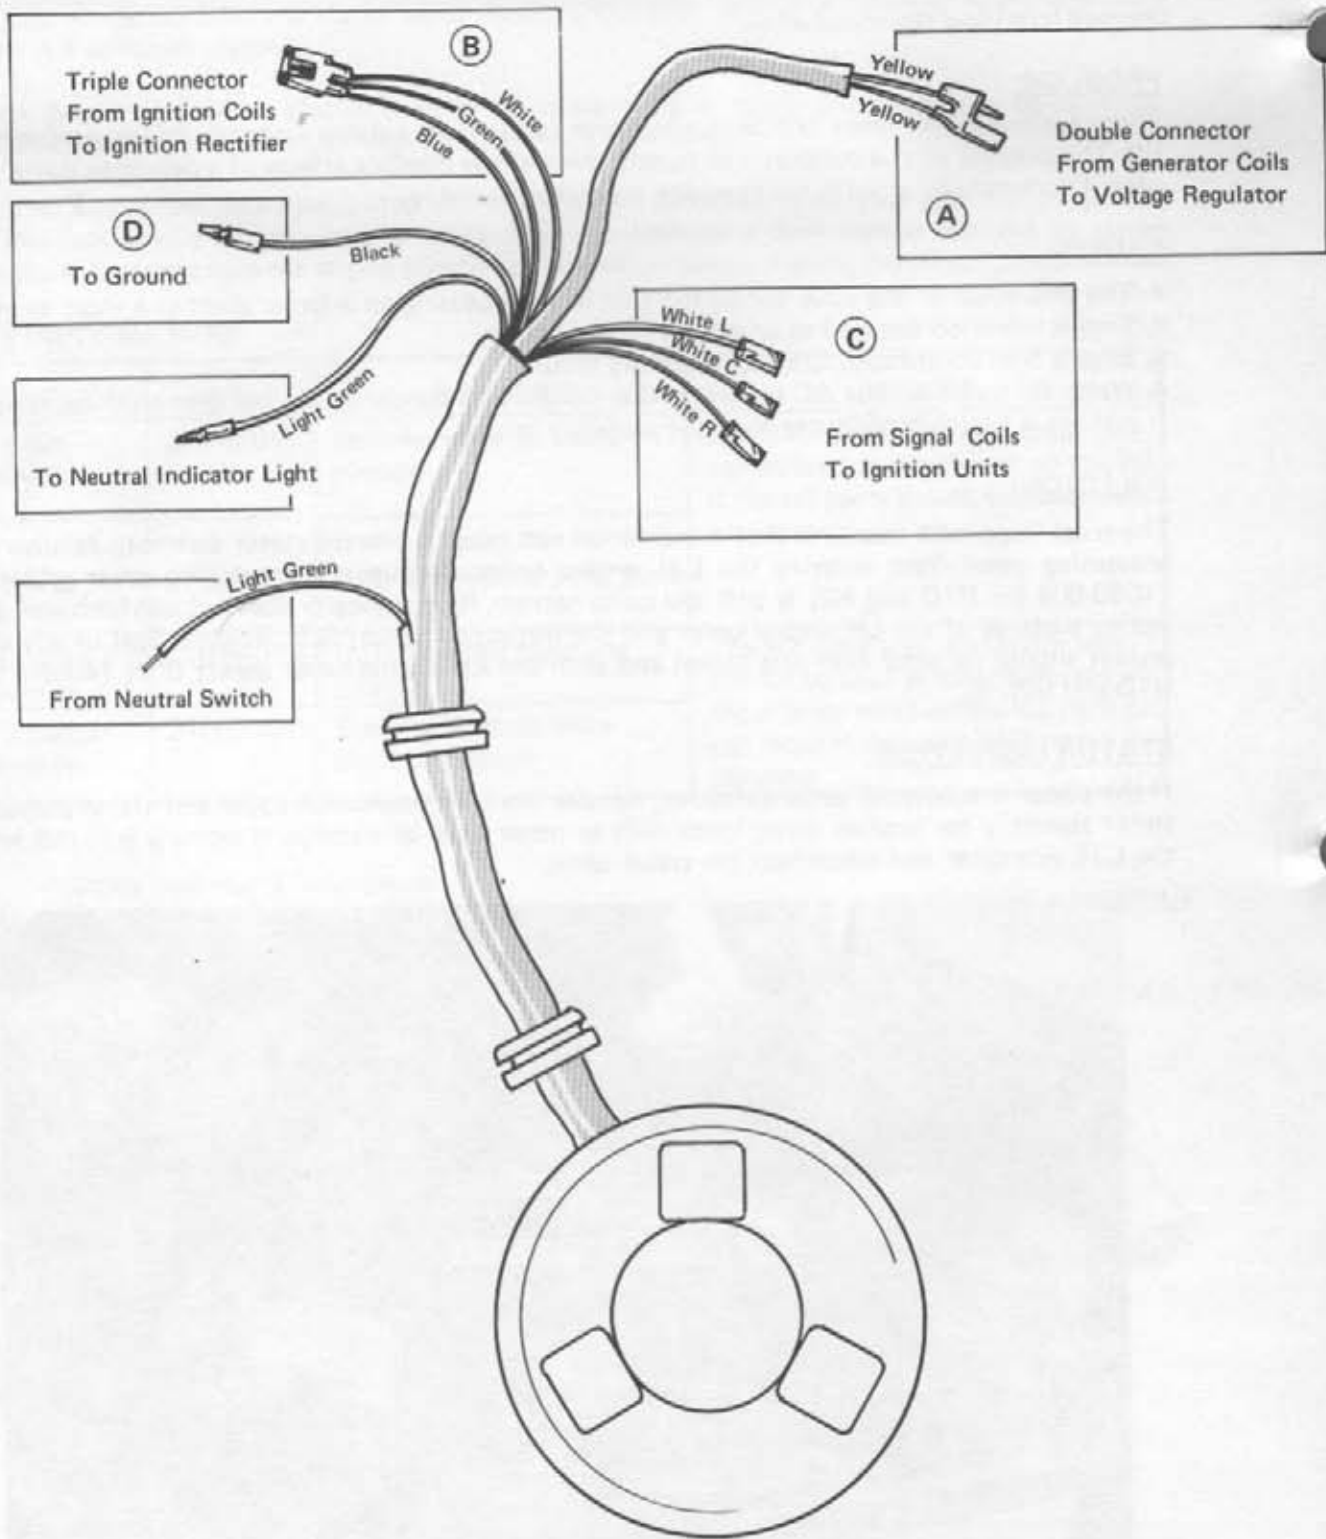
H2 Yoke Assy. and  
Circuit Test Reference Code

There are several different problems which can result from a stator assembly failure on the H1D or H2. The purpose of this bulletin is to supply some of the possible effects of a defective stator and to offer a comprehensive guide for checking the stator assembly.

1. The insulation of the coils can be too thin in areas causing an internal short or a short to ground.
2. Engine vibration can lead to an open or short circuit.
3. Engine heat contributes to stator assembly failure.
4. Water corrosion on the AC generator due partially to condensation but primarily resulting from leakage is a large contributor to stator assembly failure.

Then by using a Kawasaki ohm meter (P/N 56019-037) follow the circuit tests below. **NOTE:** It is advisable to make these checks with the stator installed on the engine, because some problems such as the stator coils touching the engine crankcase may otherwise go undetected.

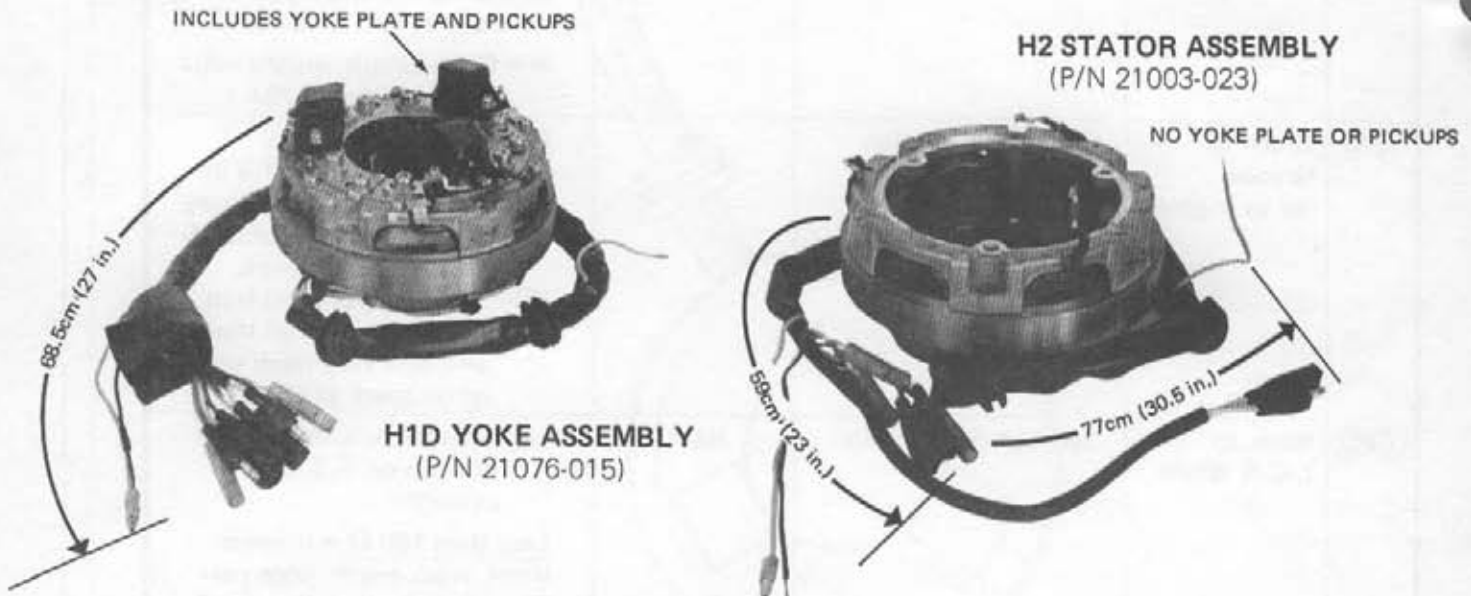
**NOTE:** The above photos illustrate the following:

1. The difference between a yoke assembly and a stator assembly.
2. The difference between an H1D and an H2 wiring harness. All the wires of the H1D harness are the same length. The wires of the H2 are two lengths — two wires longer than the H1D harness and the rest shorter. ■

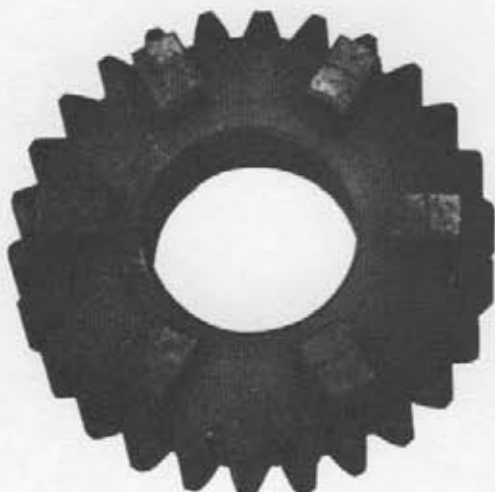
**OLD**

In the transmissions of H1 models there is a possibility for unusually fast wear on the inside of top gear on the drive shaft. As the gear wears, it begins to wobble on the shaft, eventually causing serious trouble in the transmission.

Top Gear  
 (No Bushing)  
 P/N 13136-022

To eliminate this possibility, top gear on the drive shaft has been changed. The new gear is made with a pressed in bronze bushing for extended life. This change has been applied to all H1's in production from frame number KAF-57161, and to all H2's from beginning of production.

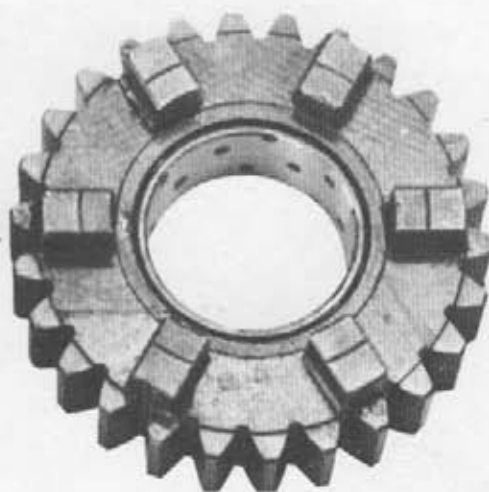
**NEW**

Top Gear  
 Bronze Bushing  
 P/N 13136-041

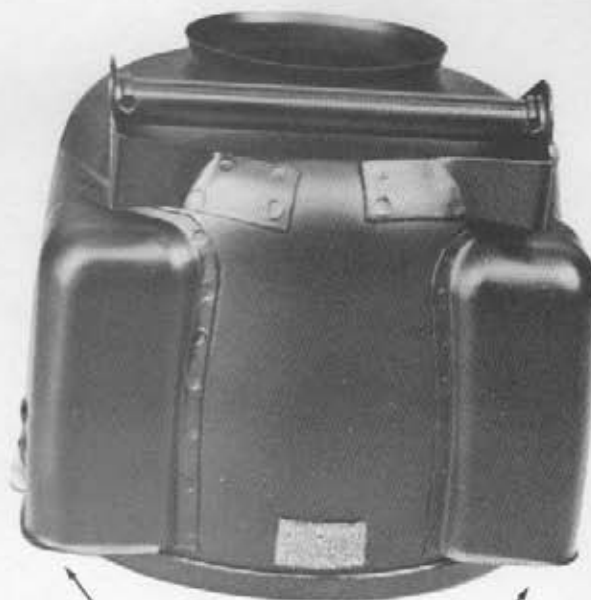
ADDITIONAL AIR INTAKES

The new air cleaner has two additional air intake ducts to increase the air intake capacity.

To improve the overall performance of the H1B, a new air cleaner was designed and a new set of carburetor specifications was used from mid-1972 production. This change is applied to all H1B's from engine number KAE-61607 and up.

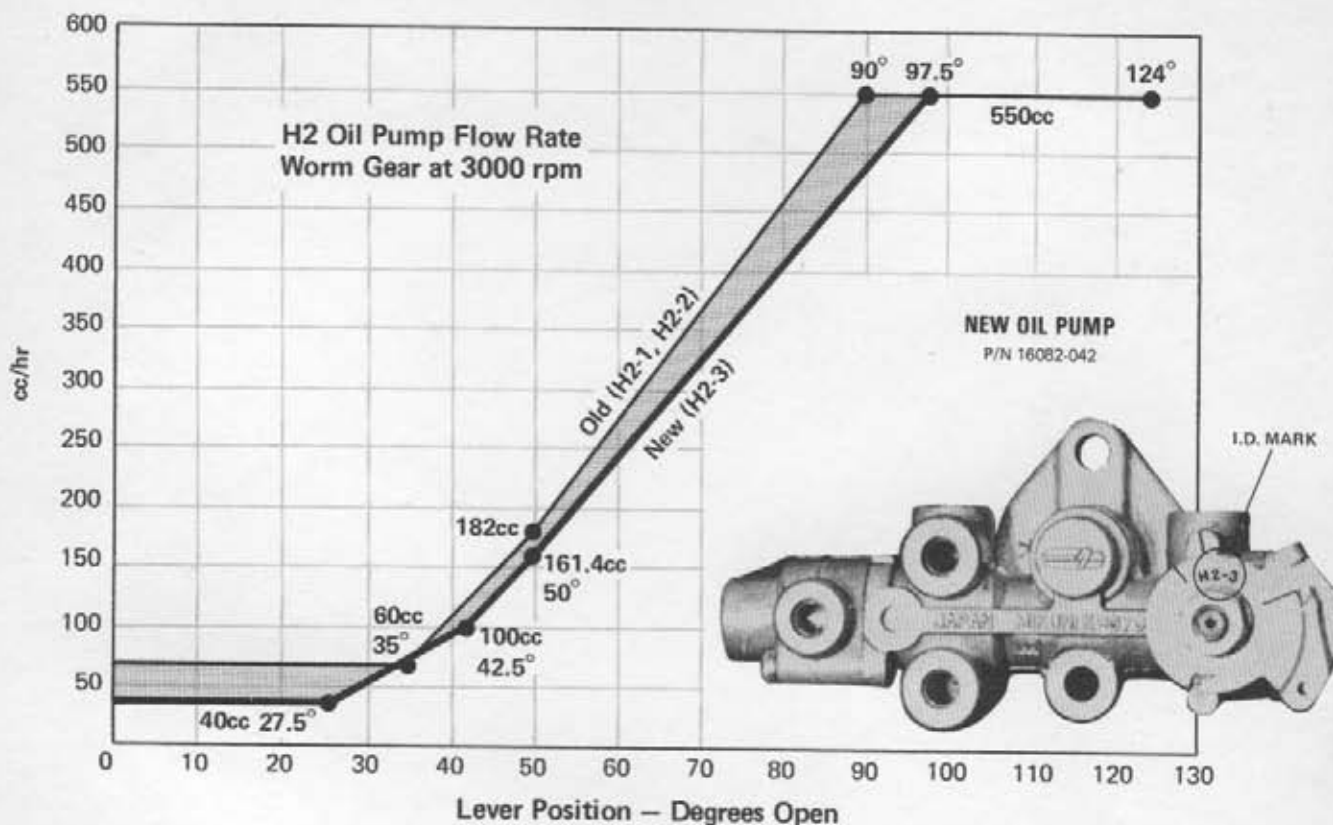
To correspond with the improved carburetor settings described in Bulletin Ser. '73 H-19 the oil pump output has been modified for slightly reduced flow. The curves for both old and new pumps are as follows:

The new oil pump has been used on and after Engine H2E-16078. The reduced oil flow, and better gas consumption provide the H2 with greater range and performance.

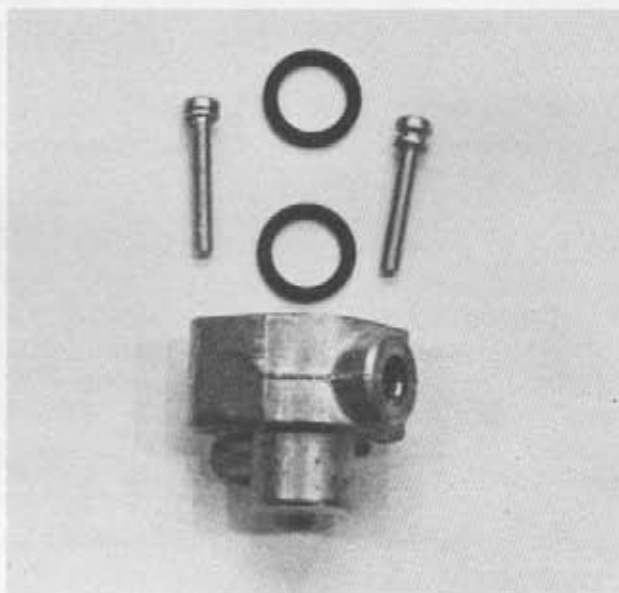
P/N 99990-016  
Three Cylinder Oil Pump  
Conversion Kit

This problem has been traced to faulty O-ring seating in the oil pump end cover. After installation, the two O-rings inside the cover shrink approximately .1 to .2mm in diameter. This shrinkage allows oil to seep around the seals and into the end cover chamber. From this point, the excess oil is pumped to the right cylinder which is serviced by the end cover orifice, resulting in smoking and premature sparkplug failure.

Whenever an oil pump is disassembled for *any* reason, the O-rings must be replaced. The end cover O-rings are P/N 16090-002.

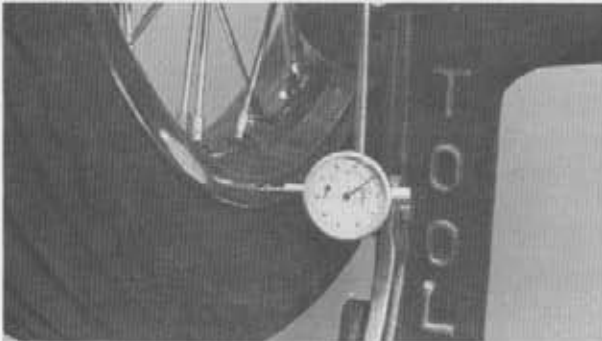
**LATERAL RUNOUT**  
Standard 1mm (.04")  
Service Limit 3mm (.12")

- A. **WHEEL TRUING:** After mounting the new tire, place the wheel in a wheel truing stand, and, making sure that all spokes are tight, adjust the lateral and radial runout. Standard lateral runout is 1mm (.04") with a service limit of 3mm (.12"). Standard radial runout is also 1mm, but the service limit is 2mm (.08").

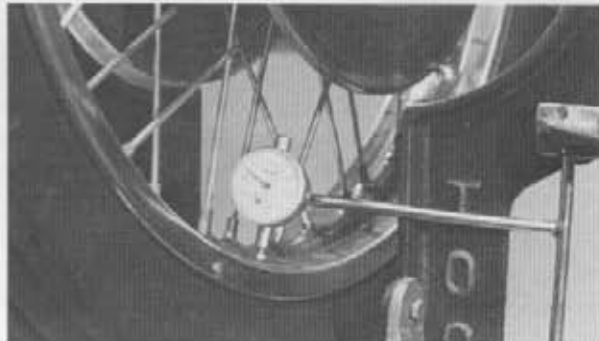
**RADIAL RUNOUT**  
Standard 1mm (.04")  
Service Limit 2mm (.08")

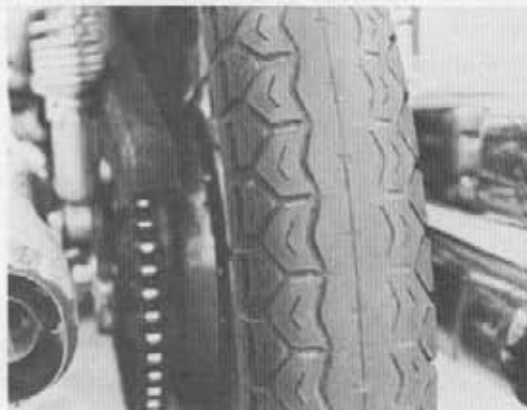
**EXCESSIVE WEAR**

- D. **REAR TIRE:** In some cases, an excessively worn back tire will contribute to high-speed wobble. Any such tire should be replaced if instability is to be cured completely.

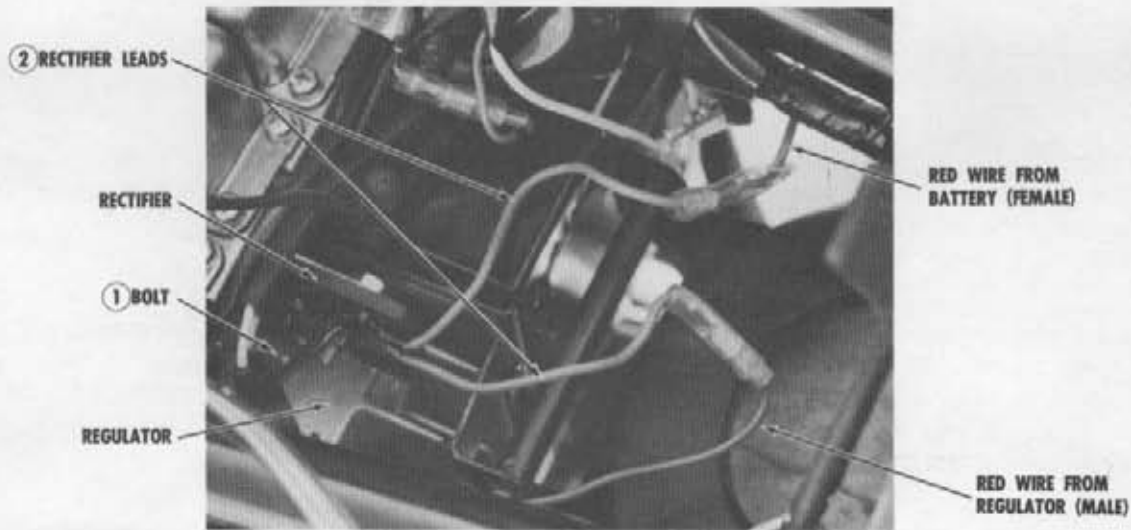
The H2 voltage regulator is connected to the battery by a red wire. This red wire carries the battery charging current when the engine is running. Because of two small resistors in the regulator circuitry, there is a slight current drain on the battery when the engine stops. In a fully charged state, it would take 2-3 weeks of inactivity for the battery to reach a serious discharge condition, because the current draw is so small (12-16 MA).

The rectifier has been incorporated in H2 motorcycles at Frame No. H2F-13266. This part *must* be installed on all H2's up through Frame No. H2F-13265.

1. Take out the top mounting bolt for the regulator. Hold the rectifier in a vertical position, and install the bolt. **NOTE:** *The rubber protector keeps the fin from shorting against adjacent metal parts.*
2. Separate the snap connector in the red wire between the battery and regulator. Connect the rectifier leads as shown.
3. Replace the air cleaner duct.

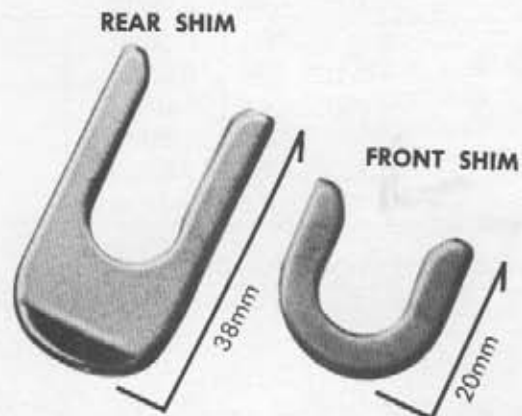
The H2 750cc engine can loosen in its frame mounting, causing rider discomfort and accelerated wear. In an extreme case, the frame lugs may fracture from engine vibration, aggravated by the loose mounts.

The frame lugs have 1.0-1.5mm clearance with the engine mounting bosses to allow easy removal/installation. These lugs are meant to be pulled in as the bolts are tightened. It has been found that the lugs take a "set", relieving tension on the mounting bolts.

For all units before frame number H2-09082, the shims *must* be installed.

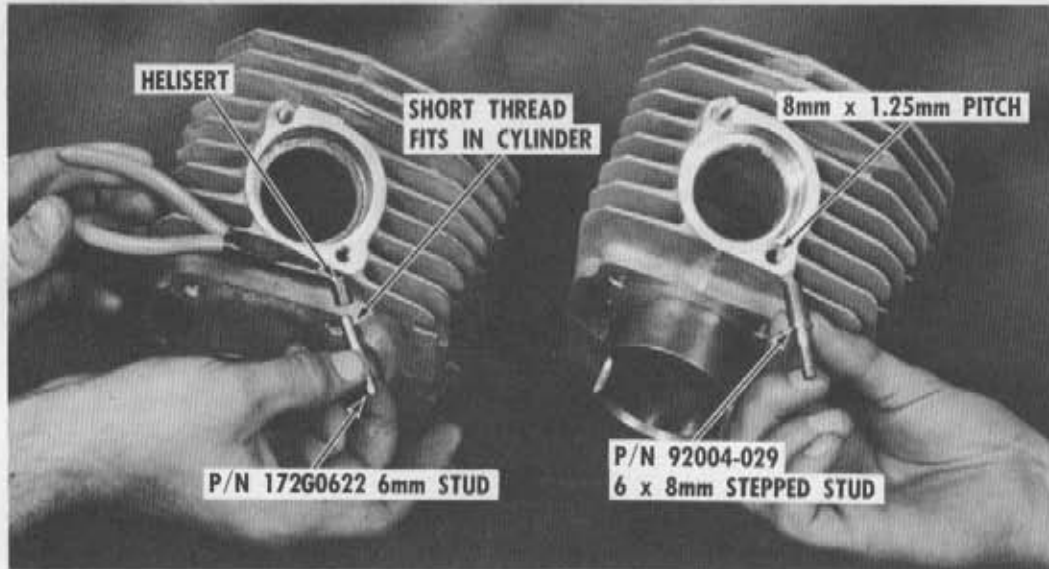
To improve servicing, the cylinder exhaust flange stud has been changed from a plain 6mm stud to a stepped 6mm x 8mm stud. The difference in parts is shown below.

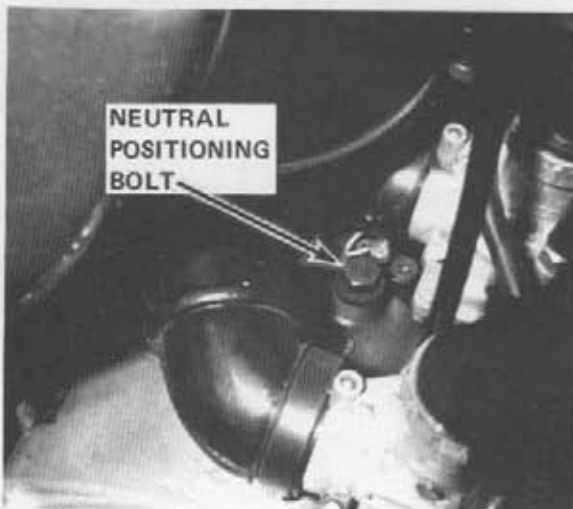
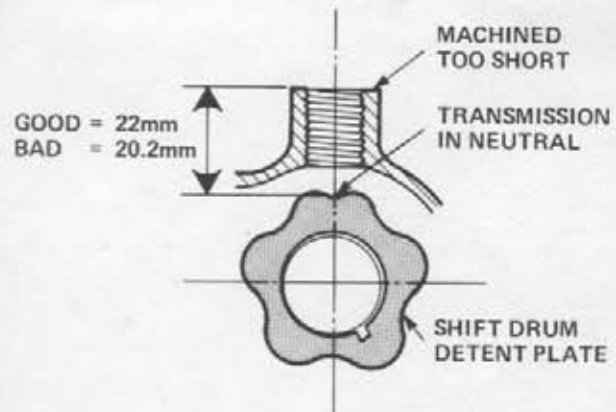
The 1976 KH500 has a neutral positioning bolt on the upper crankcase. On some early KH500's, the positioning bolt boss was machined too short. Installation of the positioning bolt and pin in a short boss may interfere with normal gear changing.

All affected units have an added gasket and washer under the neutral positioning bolt.

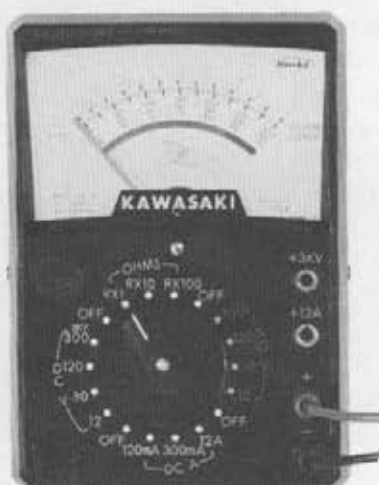
OPEN CIRCUIT

Do not hold the black lead to the slip ring under these conditions or the multimeter will be damaged. If the needle rises to 1.1 to 1.7 amps (read the 0 to 120 scale as 0 to 12.0 amps) the rotor is good. A lower reading indicates an open circuit.

With any of these types of failure, the rotor must be replaced.

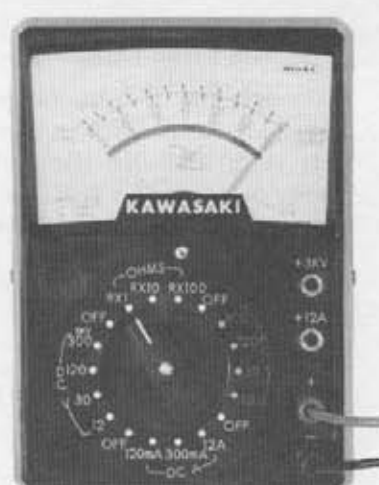
SHORT CIRCUIT

A defect which shows up only under load may be detected as follows. Set the selector switch to the "12 A" position and plug the red lead into the "+12 A" hole. Connect the red lead to the positive lead from a six volt test battery. **CAUTION:** Don't use a 12V battery or you could ruin the rotor windings. Touch the negative lead from the battery to one of the rotor slip rings. Momentarily, tap the black lead from the multimeter on the other slip ring. If the needle swings wildly across the face of the meter the rotor is shorted.

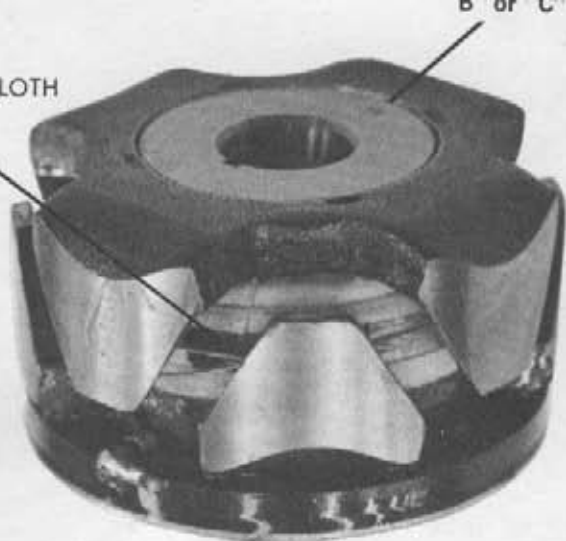
SQUARE HOLE IN CLOTH

There have been two changes in the rotor (part no. unchanged) to counter-measure this tendency toward high rpm failure. These rotors may be identified by square holes in the insulating cloth on the windings. The "B" type rotor is used in production from engine number KAE-43491 to KAE-69531. The latest modification, marked "C", changes the rubber based resin to plastic based. This rotor is used on engines KAE-69532 and up.

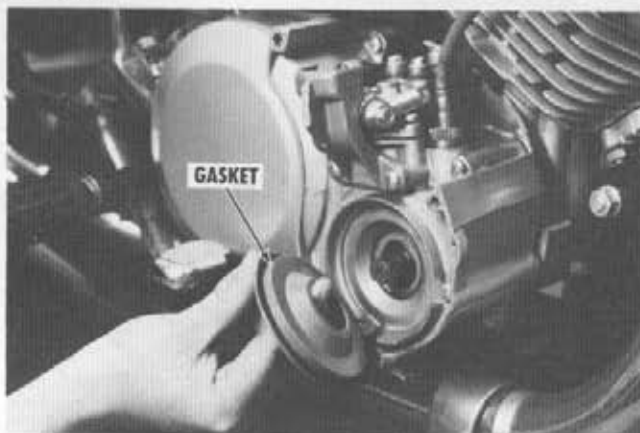
Kawasaki has a new gasket to improve sealing of the distributor chamber. It fits between the engine cover and insulator disc as shown.

This new gasket was incorporated on H1's after Engine KAE-11300, but it can be used on any H1 for better sealing.

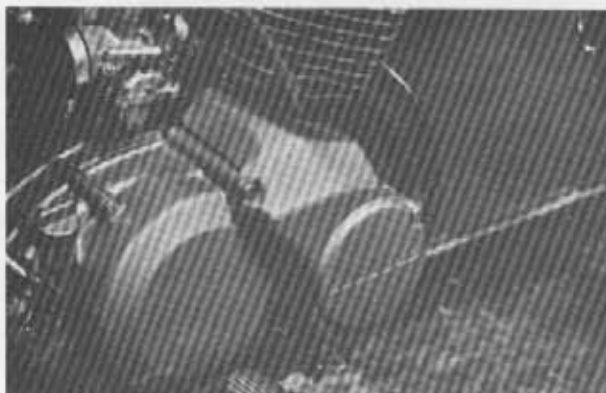
EARLY H.T. WIRING

The spark plugs generally are not the cause of the problem. We have found the high tension wiring leaks electricity to adjoining metal engine parts under high voltage loads. New spark plugs require less voltage to fire because the electrodes have sharp edges. As the plugs are used, these sharp edges are rounded off by high energy discharge and erosion from heat and chemical action in the combustion chamber. Consequently, they require an increasing amount of voltage to fire as mileage accumulates. Worn spark plugs, over-rich oil pump settings, or incorrect fuel mixtures demand more voltage from the ignition system to fire the spark plugs. These conditions "back up" the voltage in the secondary wiring until it jumps through the H.T. cord insulation to an inviting engine ground rather than fire the plugs.

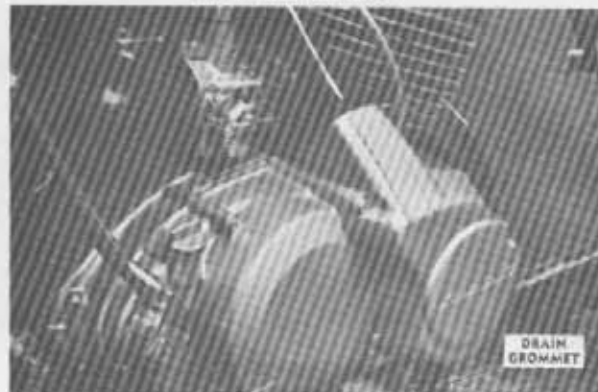
LATE H.T. WIRING

KAWASAKI has developed a set of high tension components which, after thorough testing, has proven completely reliable and eliminates the insulation leakage problem. The purpose of the new components is to re-route the H.T. cords so they are a safe distance from metal engine grounds like the oil pump, oil pump cover, engine cover, cylinders, carburetors, etc. Additionally, the type of H.T. cord has been changed from DAIICHI brand to Belden, a better-insulated cable.

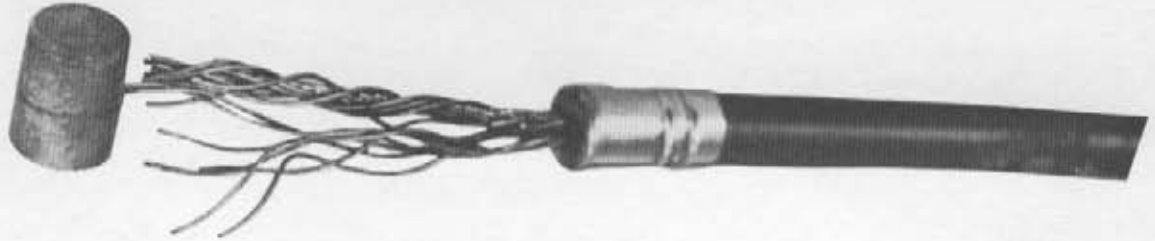
Clutch cable breakage has been a regular problem on the S1 and S2. This is primarily the result of excessive wear at the hand lever. The cable flexes at the lever and the cable strands break at the lead nipple.

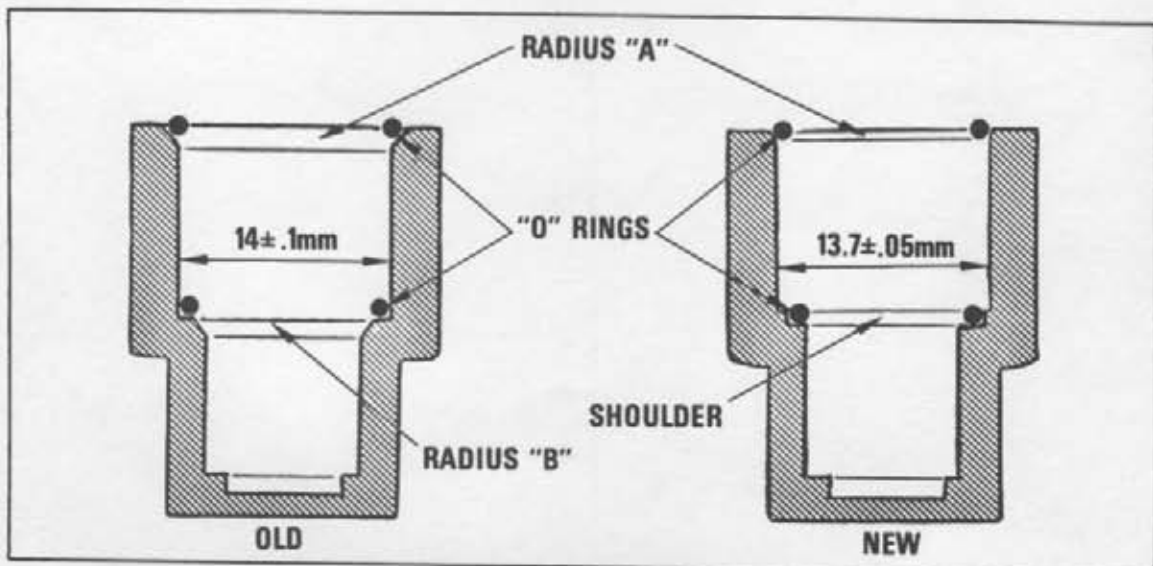
This problem has been traced to faulty O-ring seating in the oil pump end cover. After installation, the two O-rings inside the cover shrink approximately .1 to .2mm in diameter. This shrinkage allows oil to seep around the seals and into the end cover chamber. From this point, the excess oil is pumped to the right cylinder, which is serviced by the end cover orifice, resulting in smoking and premature spark plug failure.

- A. Radius "A" has been decreased in depth to give the O-rings less "squish" space, making a tighter seal.
- B. Radius "B" has been eliminated altogether to improve the seal at that point.
- C. The internal diameter of the chamber has been decreased from  $14 \pm .1\text{mm}$  to  $13.7 \pm .05\text{mm}$  to compensate for O-ring shrinkage.
- D. A slight shoulder has been added to the base of the new chamber to further compress the O-ring.

To remedy this problem, the oil pump end cover has been redesigned to stop oil seepage. The illustration below points out the differences between the old and new covers.

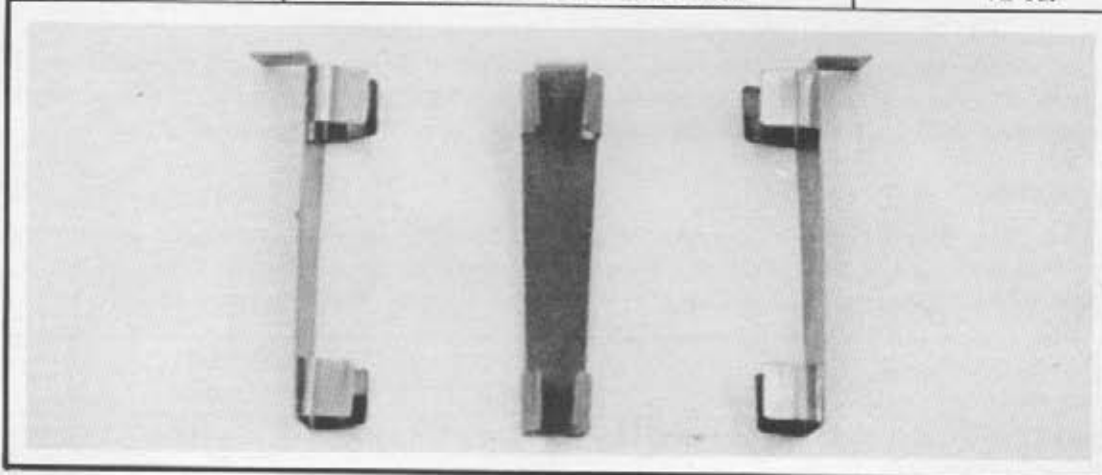
The rattling noise is evidence of excessive clearance between the clutch housing drive fingers and the driven tabs on the friction plates. Slight variations in the clutch housing RPM resulting from engine firing impulses cause the housing to speed up and slow down slightly, and the tabs of the friction plates, held together by the clutch spring, are struck on one side (load) and then the other side (coast) by the housing fingers. Standard clearance between the fingers and the tabs is 0.002-0.022" (0.05-0.555 mm). As the clearance exceeds 0.010" (0.25mm), however, clutch rattle becomes more evident.

To take up the excessive clearance, Kawasaki has prepared clutch finger shims. Three shims are needed to repair one clutch.

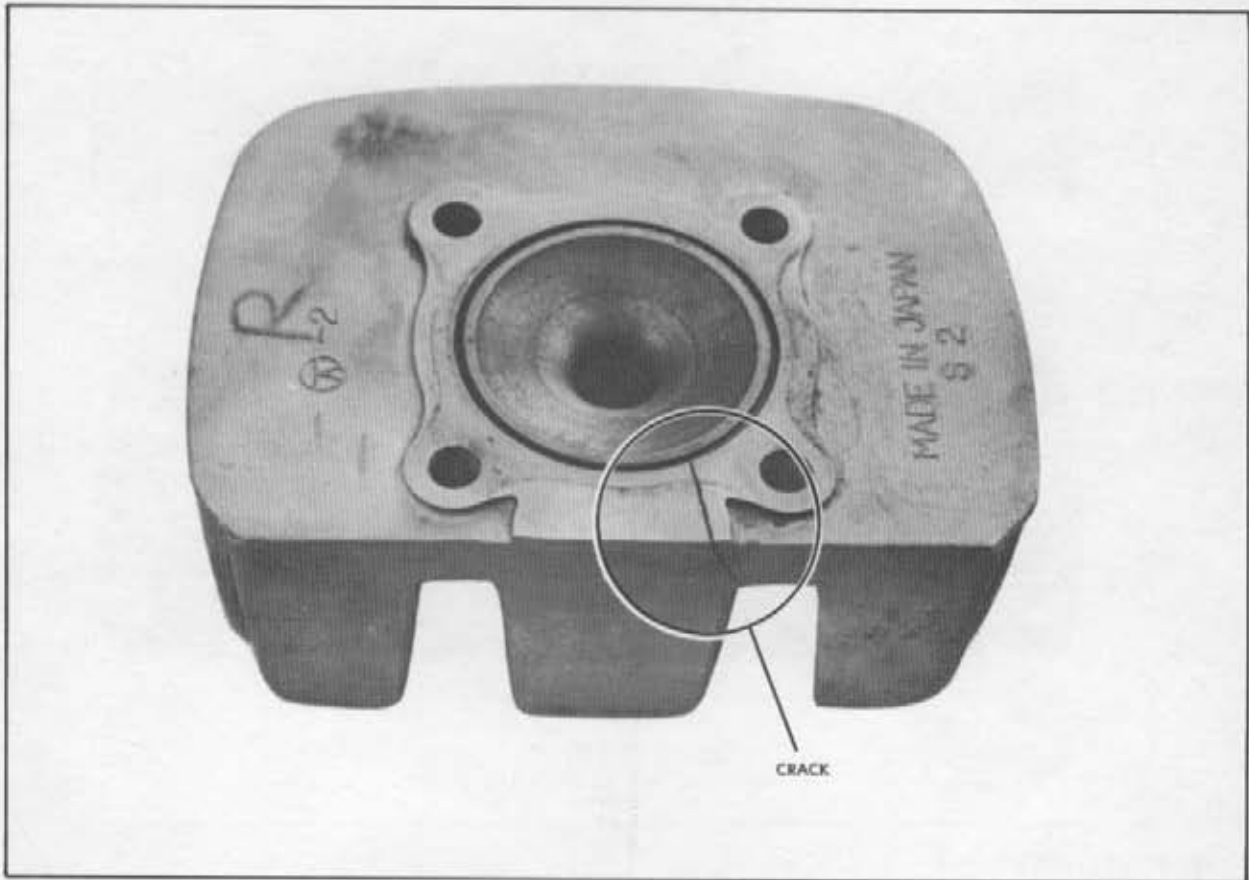
On some early S2 machines, there is a slight possibility of the cylinder heads cracking as shown below. Our experience indicates that the fault may occur under conditions of hard usage, such as extended full throttle operation for long periods of time.

With a cracked cylinder head, there is a slight power loss in the high RPM range in 4th and 5th gear. On some units the engine may detonate because fuel/air mixtures are upset from leakage. Generally, a cracked head will not be visually noticeable unless the head is removed from the engine.

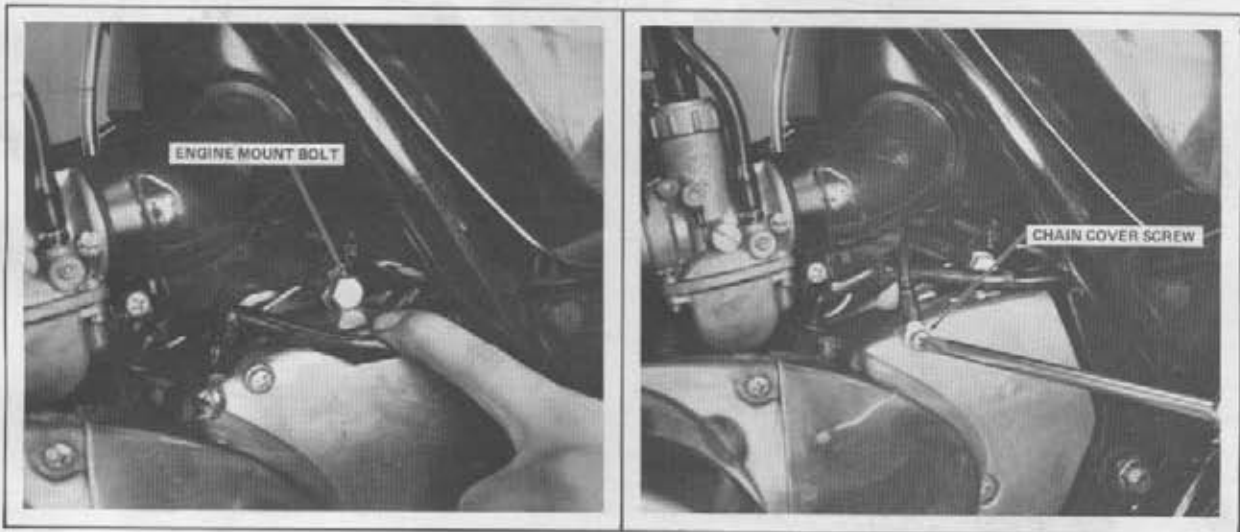
This problem has been cured in production after frame number S3F-005187 by the addition of a ground wire between the frame and the engine chain cover. A heavy gauge lead is used to assure the least possible resistance between the engine and frame.

For proper ignition performance under all conditions this ground wire (P/N 26011-084) must be installed on all S3 motorcycles before frame number S3F-005187.
